# REPAIRING OF COLUMNS OF THE SKI LIFT IN THE SKI CENTER

Nazif Jashari<sup>1</sup>, Sveto Cvetkovski<sup>2</sup>

## Abstract

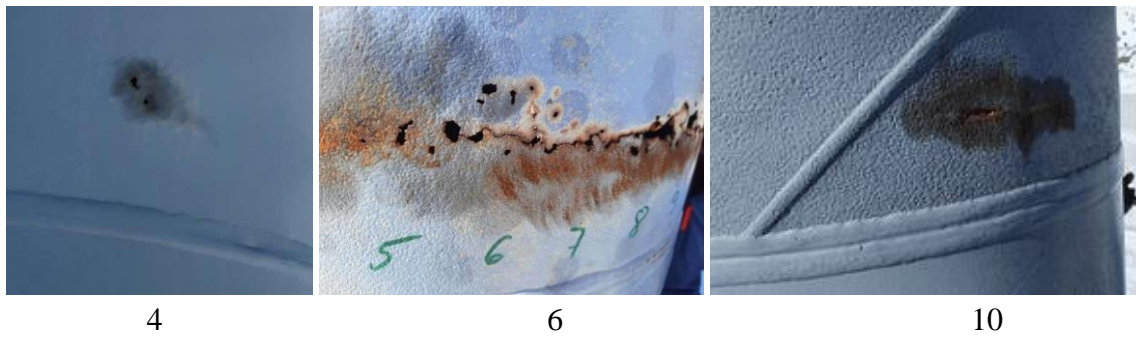
The damages of the columns are given in figure 1 It is obvious that they are the result of a corrosion attack of a long period of exploitation in extreme weather conditions, and that they can cause the demolition of the ski-lift if repair is not performed. The most characteristic is column 6. Part of the columns is completely perforated. The first thing which was made is measuring of thickness of columns around the cracks. It was concluded that the thickness around the cracks is very low. Because of that is decided to cut this thinned and perforated. Layer and embed new segments from the same material and thickness as the column itself. Segments with dimensions 800x200x5 should be prepared for all columns.

Figure 1. Damaged columns of the ski-lift

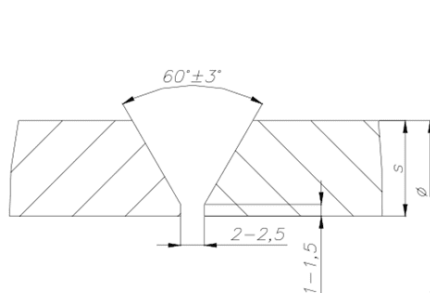
Figure 4. Prepared V-groove

It must cut perforated and thinned segments. To prepare and shape a new segment from the same material and identical thickness like a column. Between the segment and column must form V- groove. Preparation is to be made as in figure 4. The number of passes is shown a figure5. Tack welds are planned between the segment and column. The length of tack weld must be about 10 mm.

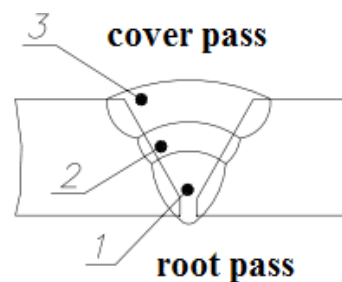
Figure 5. Number of passes

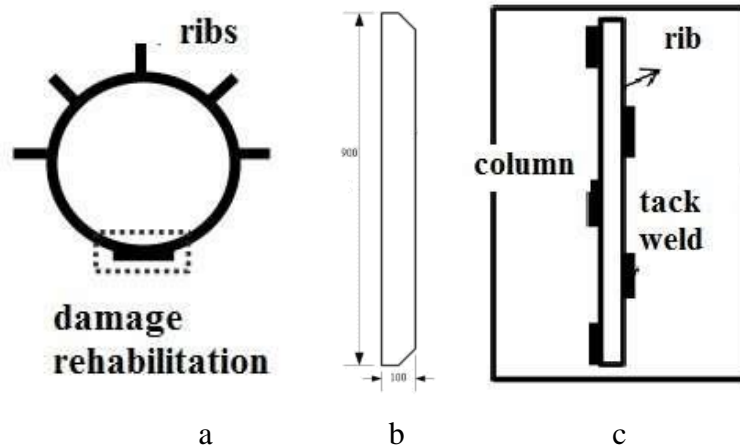
Figure 6. Strengthening of column by ribs [1-4]

Before to start with cutting the damaged sections it is planned to make strengthen of columns. It means that temporary welding of ribs must be done. Tack welding is predicted to connect ribs for columns. Ribs are located on the opposite side of the damaged segment which must be cut. The ribs will be set up temporarily with short welds (figure 6). The predicted dimensions of ribs are 900x1000x10. If there is pass over weld, the proper notch must be made. After finishing with the cutting of corroded segments and embedding a new one, temporary ribs are removed.

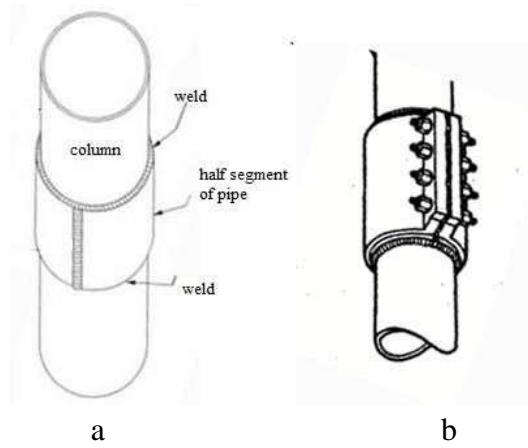
Figure 7. Column after strengthening [5-9]

After welding a new segment, a painting of the segment itself shall be made. Additionally strengthening of the columns shall be made. Two halves of pipes shall be screwed and welded, figures 7 and 8.

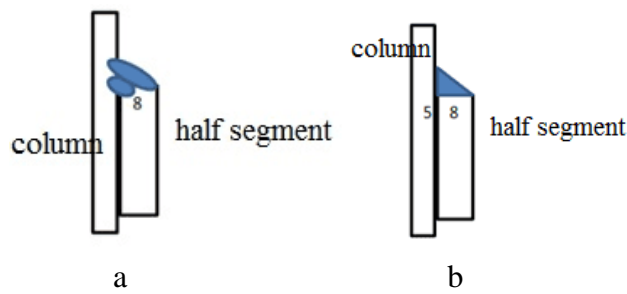
Figure 8. Welding of half pipes for columns

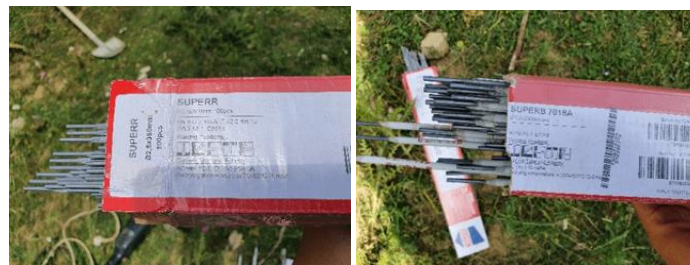
Figure 9. Electrodes used for repairing columns according to prescribed technology

Used electrodes for repairing are given in the figure 9.

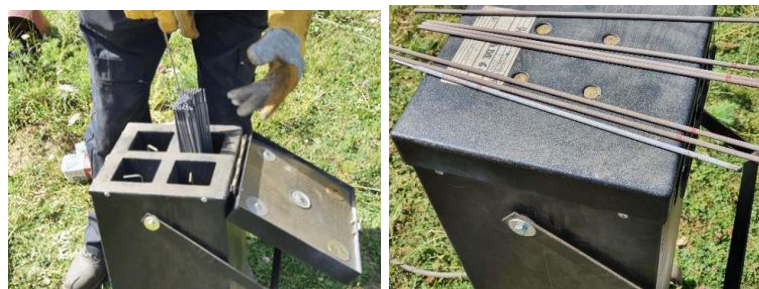
Figure 10. Drier for electrodes

Electrodes were properly stored during transport in the original covering. Before usage, they were dried at the appropriate temperature, figure 10.

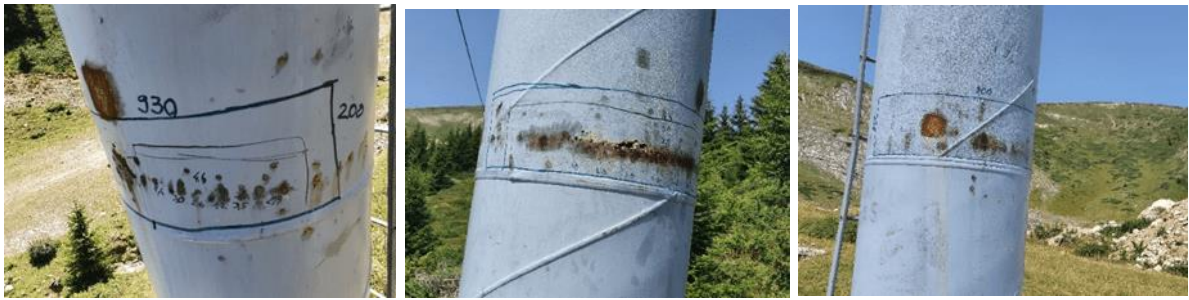
**Figure 11.** Columns for repairing

Activity for rehabilitation of columns starts with marking the corroded positions which must be cut, as is shown in figure 11.

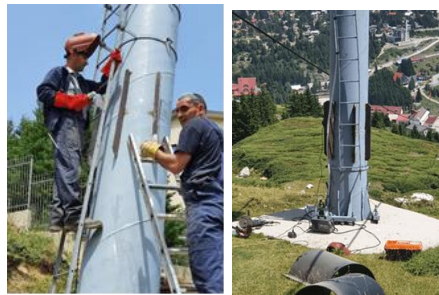
**Figure 12.** Welding temporary ribs

According to the prescribed technology temporary ribs for stiffening was tack welded to suppress the demolition of columns before cutting off corroded segments as is shown in figure 12.

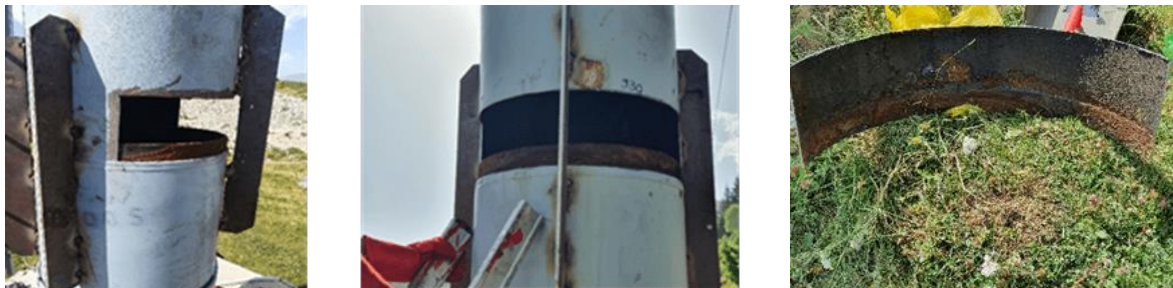
Then carefully cutting of corroded (damaged) segments starts at positions where new segments had to be embedded (figure 13). After cutting the segment much corrosion damages was detected on the inner side of the column as can be seen in the figure 13.

**Figure 13.** Columns after cutting

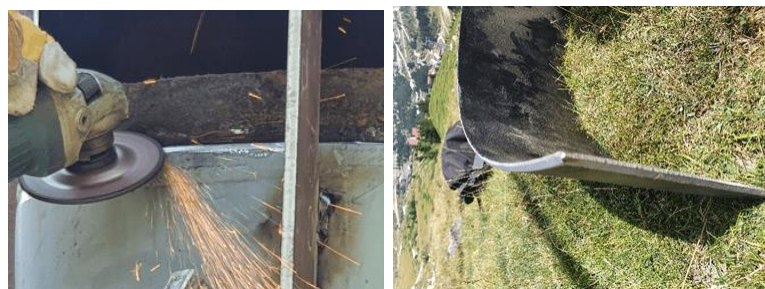
**Figure 14.** Preparing of parts for welding

The next activity was the preparation of segments and columns for welding. It is shown in figure 14. Edges of segments and columns were made by grinding. Tack welding of segments for columns is shown in figure 15.

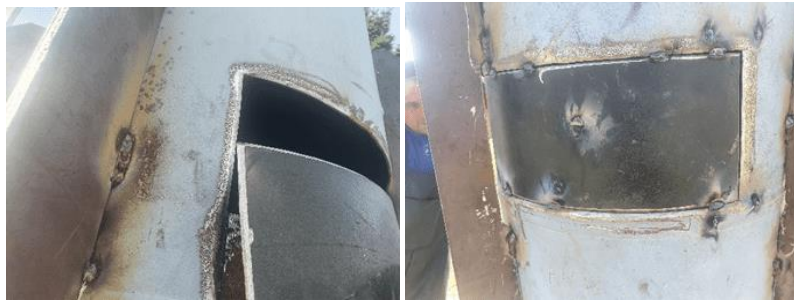
**Figure 15.** Tack welding

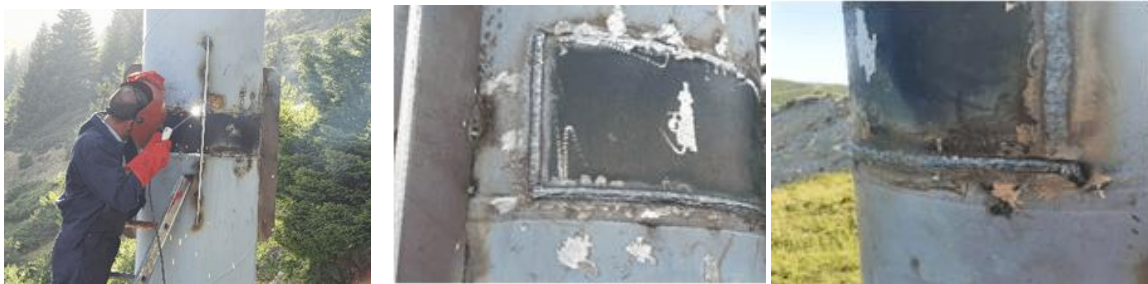
**Figure 16.** Welding of embedded segments

When the positioning of segments was completed, their welding started. A rutile electrode was used for the root pass and a basic electrode for the covering pass. (Figure 16).

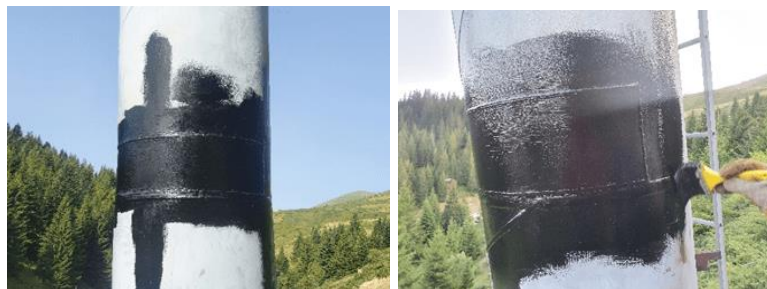
**Figure 17.** Painting of welded segments

After laying any new pass grinding and cleaning of the weld with a steel brush was made. NDT inspection was done to check the quality of the wedding operation. And, after that painting was done.
