NONSTRUCTURAL SAFETY OF HOSPITALS FOR DISASTER: A CASE STUDY OF PHI "GENERAL HOSPITAL" STRUMICA

This study analyzes the second component contributing to the vulnerability of the hospital complex—the non-structural safety of the PHI "General Hospital" Strumica, with a focus on the 'Main Building' as the central facility based on the Hospital Safety Index as the chosen measurement tool. This building is the largest in terms of surface area and accommodates the majority of the hospital's functions. As part of the analysis process, an assessment of the non-structural elements—including architectural components, infrastructural protection and accessibility, critical systems, installations, equipment, and reserves—was conducted and presented, specifically for the Main Building.

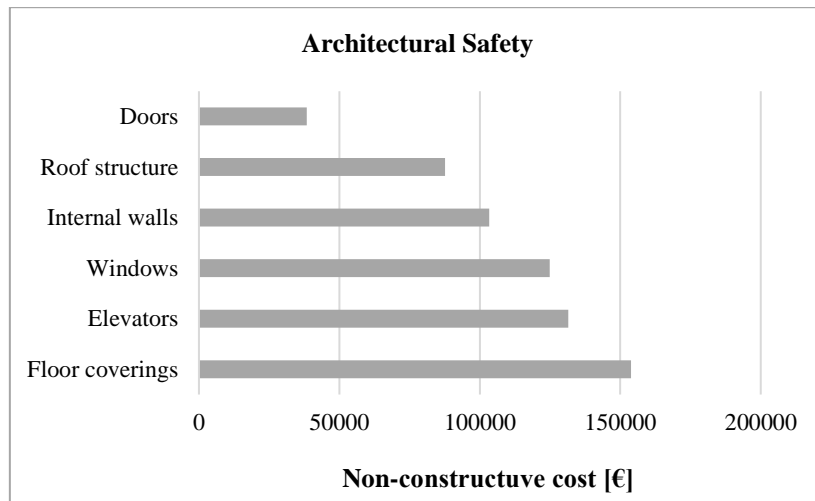
Figure 3. Cost Analysis of Non-Structural Architectural Elements

The results obtained (**Figure 3**) indicate that the highest non-structural costs for replacement, repair, or rehabilitation are expected for the floor coverings of the “Main Building,” with a total estimated cost of approximately 153,776€, based on current market prices in the Republic of North Macedonia.

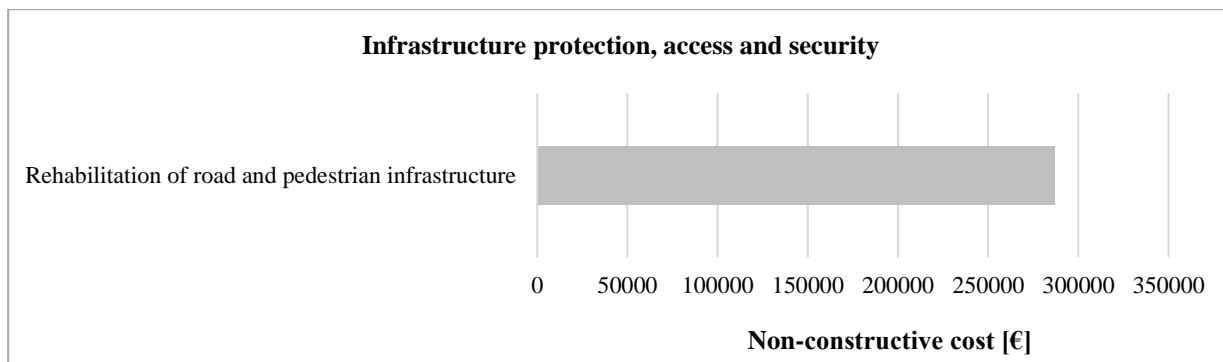
Figure 4. Cost Analysis of Non-Structural road and pedestrian infrastructure

The results (**Figure 4**) indicate that the highest estimated non-structural cost for replacement, repair, or rehabilitation of the existing road and pedestrian infrastructure within the hospital complex is 287 049€, based on current market prices in the Republic of North Macedonia.

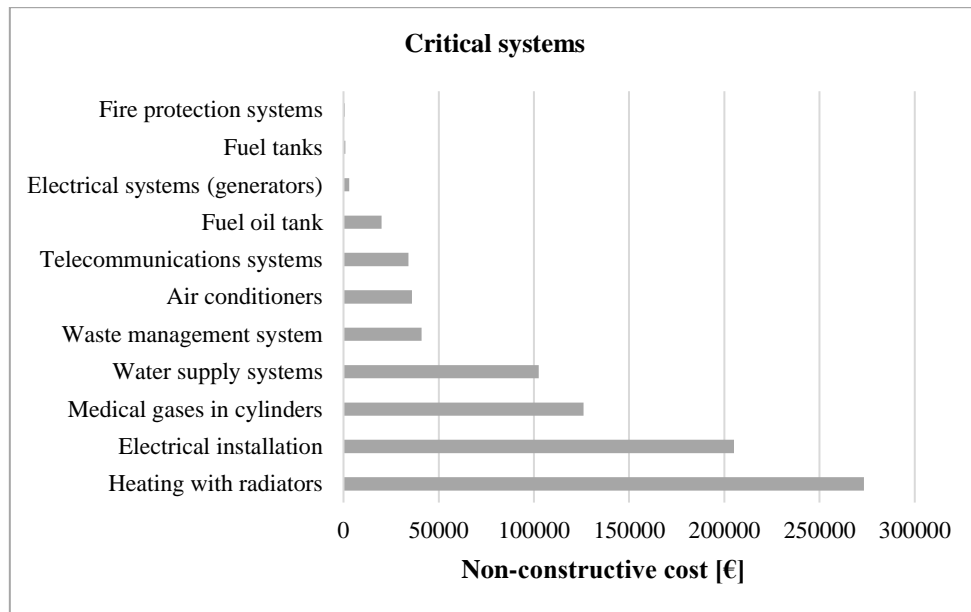
Figure 5. Cost Analysis of Non-Structural cost of Critical Systems

The results obtained from the prepared construction bill of quantities show that the highest non-structural costs for replacement/repair/rehabilitation of critical systems in the Main building are expected for the heating units with a total cost of approximately 273,380€ based on current market prices in the Republic of North Macedonia.

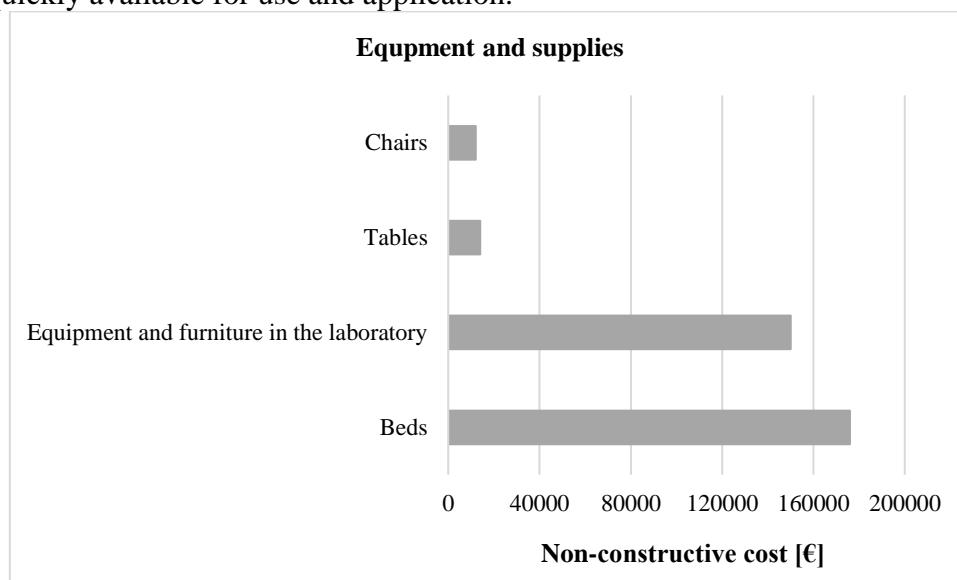
Figure 6. Cost Analysis of Non-Structural cost of Equipment and supplies

The results obtained (**Figure 6**) show that the highest non-structural replacement costs for equipment and supplies are expected for hospital beds in the “Main Building” with a total cost of around 176,000€.
