AN OVERVIEW OF EXPOSURE RISK ASSESSMENT METHODOLOGY. A CASE STUDY OF: PHI "GENERAL HOSPITAL" STRUMICA

This paper presents the development of an exposure model for PHI "General Hospital" Strumica, one of the largest hospital complexes in the southeastern part of North Macedonia. To support this research, an exposure database was created, cataloging seven existing buildings in the hospital complex using the building taxonomy developed by the Global Earthquake Model (GEM) for natural hazard risk assessment.

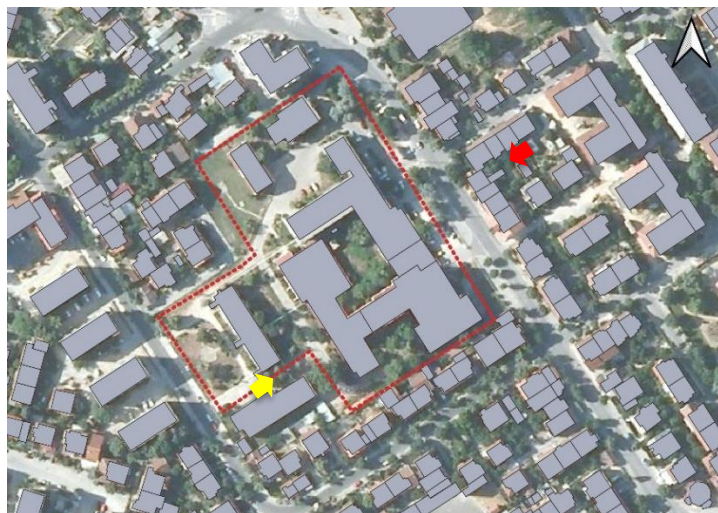
Figure 1. External traffic accesses to the PHI “General Hospital” Strumica (a) st.Mladinska (red), (b) st.Panche Peshev (yellow)

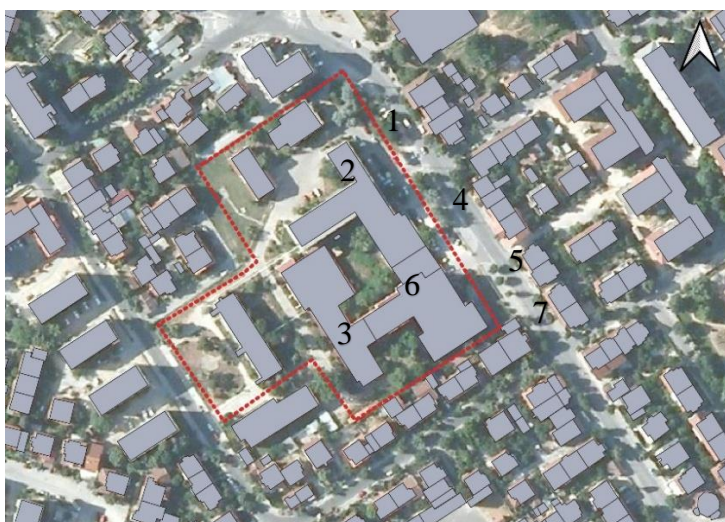
1. Infectious Diseases Department
2. Administrative Building
3. Dermatology Clinic
4. Main Building (4 departments, 6 clinics, X-ray service)
5. Admissions and Discharges
6. Physical Therapy and Rehabilitation; Pathology Laboratory; Radiology
7. New Hospital Wing

Figure 2. Schematic Layout of the Buildings within the “General Hospital” Strumica
All the listed buildings (**Figure 2**) within the complex were constructed between 1969 and 2021, in compliance with the applicable design and construction codes in our country (Министерство за транспорт и врски на РСМ, 2020).

The PHI “General Hospital” Strumica, as a secondary healthcare facility serving over 220,000 residents (Влада на РСМ Дирекција за заштита и спасување Подрачно одделение, 2015), is a pavilion-type hospital complex consisting of the following structural-functional units (**Figure 2**):

All information for the seven buildings analyzed within the hospital complex (**Figure 2**) was obtained through a process of vectorization and attribution of the real estate (buildings) using two software tools: CAD and GIS (Angova-Kolevska & Vitanova, 2024). The graphical representation of the buildings was created in AutoCAD, while the attribute data for building surface areas were processed in QGIS (<https://qgis.org/en/site/>, n.d.). This analysis was based on data sourced from the Official Web Portal of the Real Estate Cadastre Agency of North Macedonia (<https://ossp.katastar.gov.mk/OSSP/>, n.d.) and the authorized local offices of the agency in Strumica.

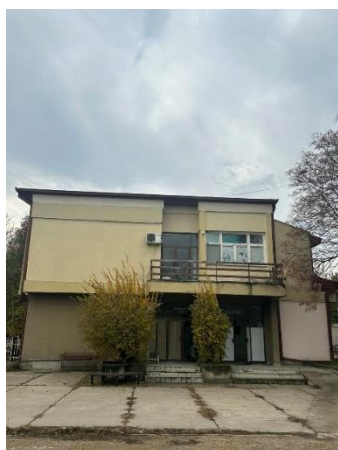
CR_LFINF-CDM-0_H2

Infectious Diseases Department built as a reinforced concrete structure with infilled walls made of hollow brick (LFINF). With G+1 (2 storeys above the ground). It was built in 1981, within the period from 1964 to the present (CDM), in accordance with the current seismic design codes.

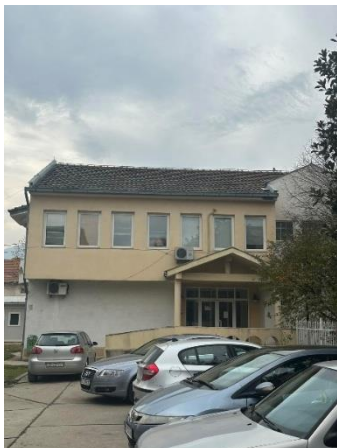
CR_LFINF-CDM-0_H2

Administrative Building built as a reinforced concrete structure with infilled walls made of hollow brick (LFINF). With G+1 (2 storeys above the ground). It was built in 1981, within the period from 1964 to the present (CDM), in accordance with the current seismic design codes.

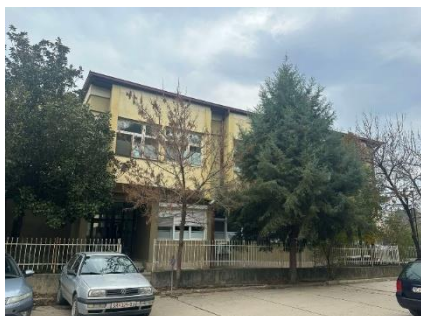
CR_LFINF-CDM-0_H2

Dermatology Clinic built as a reinforced concrete structure with infilled walls made of hollow brick (LFINF). With G+1 (2 storeys above the ground). It was built in 1969, within the period from 1964 to the present (CDM), in accordance with the current seismic design codes.

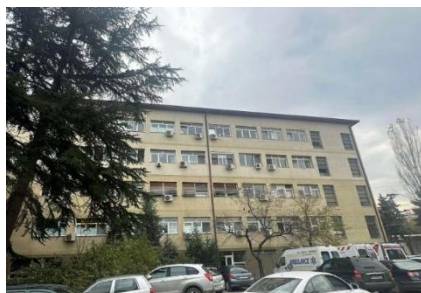
CR_LFINF-CDM-0_H5

Main Building (4 departments, 6 clinics, X-ray service) built as a reinforced concrete frame structure with infill made of reinforced concrete (LFINF). With G+4 (5 storeys above the ground). It was built in 1970, within the period from 1964 to the present (CDM), in accordance with the current seismic design codes.

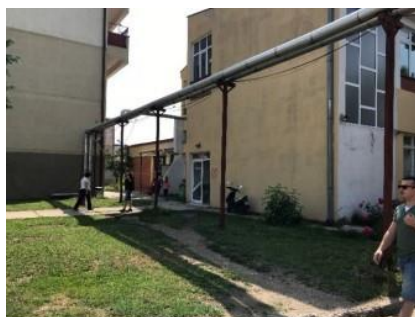
CR_LFINF-CDM-0_H1

Admissions and Discharges building built as a reinforced concrete structure with infilled walls made of hollow brick (LFINF). Built as a single-storey building (G). It was built in 1970, within the period from 1964 to the present (CDM), in accordance with the current seismic design codes.

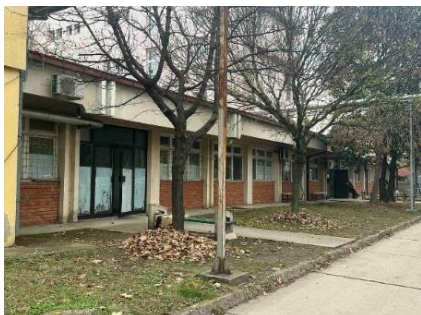
CR_LFINF-CDM-0_H1

Physical Therapy and Rehabilitation; Pathology Laboratory; Radiology building built as a reinforced concrete frame structure with infill made of hollow brick (LFINF). Built as a single-storey building (G). The building was built in 1981, within the period from 1964 to the present (CDM), in accordance with the current seismic design codes.

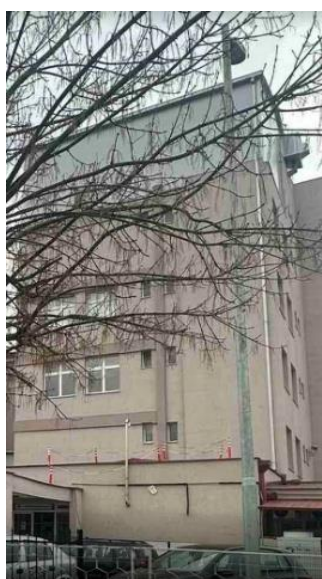
CR_LDUAL-DUM_H5

New Hospital Wing built as reinforced concrete structure with dual frame wall (LDUAL). With G+4 (5 storey above the ground). It was built in 2021, and has not yet been put into use. It demonstrates medium ductility (DUM).

What can be concluded from the research and the site inspection made by the author of this paper is that all the buildings within the hospital complex as presented and shown above in the paper are built as reinforced concrete structures with infill made of reinforced concrete or hollow brick (LFINF), built between 1969 and 2021. The only exception is the New Hospital Wing, which is built as a reinforced concrete structure with dual frame wall (LDUAL) (**Table 2**).
