IMPLANT FAILURES IN THE ESTHETIC ZONE- CASE PRESENTATION

Kenan FERATI, Arbëresha BEXHETI FERATI, Sabetim ÇERKEZI, Jeta BEXHETI-REXHEPI, Armend REXHEPI, Amar FERATI

University of Tetova – Faculty of Medical Sciences – Dentistry Study Program

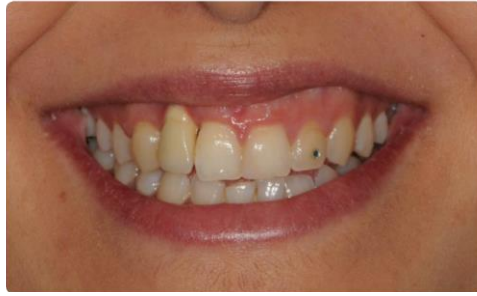
Gingival disharmony: The gingival margin at tooth 12 was positioned more apically compared to adjacent central incisor and canine, creating visible asymmetry, exacerbated by a high smile line.

Disproportionate crown: The existing prosthetic crown was long and narrow versus the left lateral incisor, with unnatural morphology.

Occlusal disharmony: Crown architecture was incongruent with the mandibular antagonists, disrupting visual and functional harmony.

Arch disharmony: The restoration did not integrate into the maxillary arch form, breaking the incisal line and smile symmetry, impacting the patient's confidence.

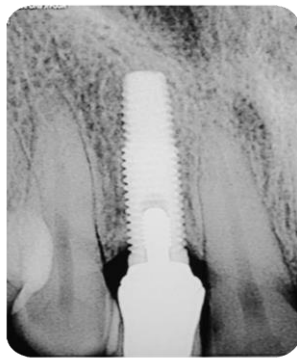
Radiographically, the implant was well integrated with no signs of periapical radiolucency or bone loss. Nonetheless, esthetically it failed to meet modern smile zone standards, classifying it as an esthetic failure requiring surgical and prosthetic correction.

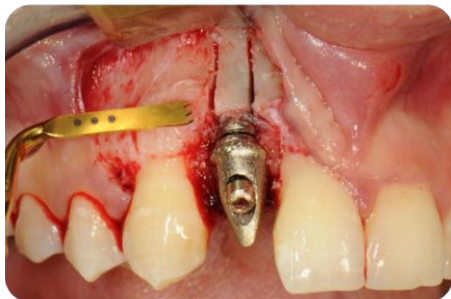
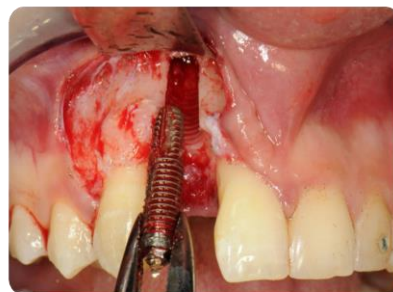
Implant removal and bone defect management an atraumatic explantation was performed using piezo-surgery to preserve surrounding tissues. A combined horizontal (3 mm) and vertical (10 mm) vestibular defect was identified post-explantation.

Hard tissue augmentation was performed concurrently using:

- Biocompatible particulate bone substitute
- Autogenous growth factors: PRF-A and injectable PRF
- Application of PRF membrane and Aloderm® acellular dermal matrix

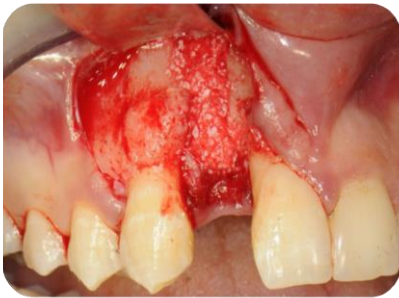
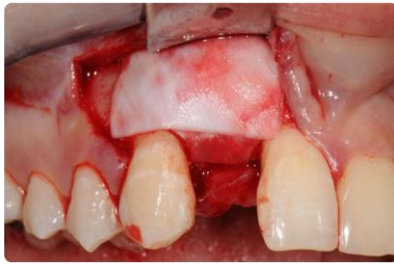
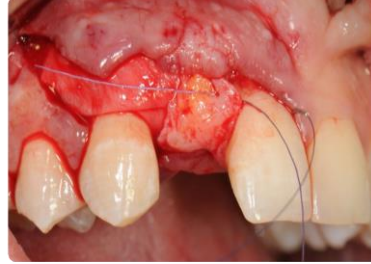
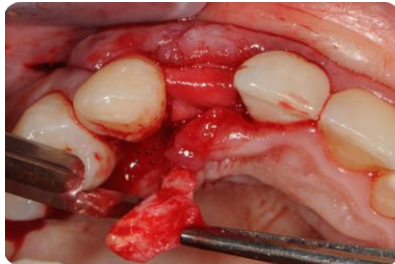
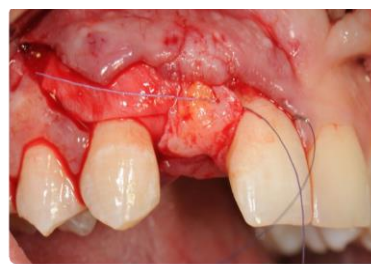
A palatal graft was harvested and tunneled into the vestibular defect using a minimal incision technique to preserve vascular supply. This enhanced gingival thickness and contour, preparing the site for future restoration.

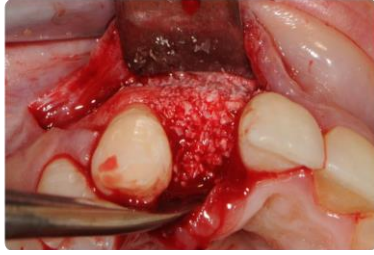
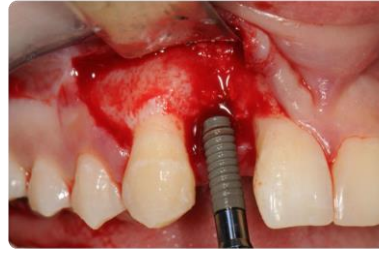
A precision-designed mucoperiosteal flap was elevated. CBCT confirmed adequate bone volume. A new implant was placed in optimal 3D position—respecting gingival margins, interdental papillae, and biomechanical axes—using standardized osteotomy protocols.

Concurrent soft-tissue graft, an additional palatal mucogingival graft was tunneled to optimize vestibular gingival thickness, contour, and long-term esthetic stability.

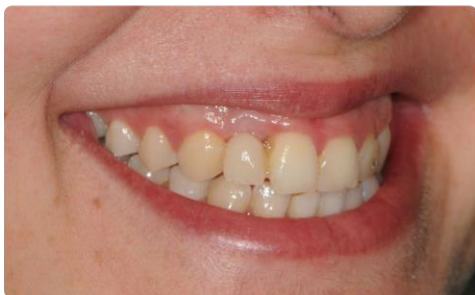
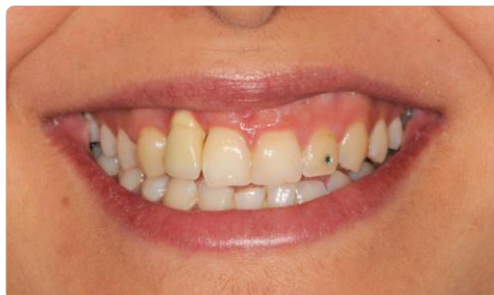
A precise PVS transfer impression was taken. A custom zirconia abutment and monolithic zirconia crown were fabricated for optimal light transmission, strength, and esthetic integration. Morphology and shade matched the contralateral lateral incisor.

- Complete integration into the maxillary arch
- Pink and white esthetic scores (PES/WES) harmony
- Undetectable restoration during speech or smiling
- Optimal occlusal and functional performance
