ISLAMIC CULT MONUMENTS IN MITROVICA AND ITS SURROUNDINGS 2

Pajazit HAJZERI , Qazim NAMANI*, Faik SAHITI*

Abstract

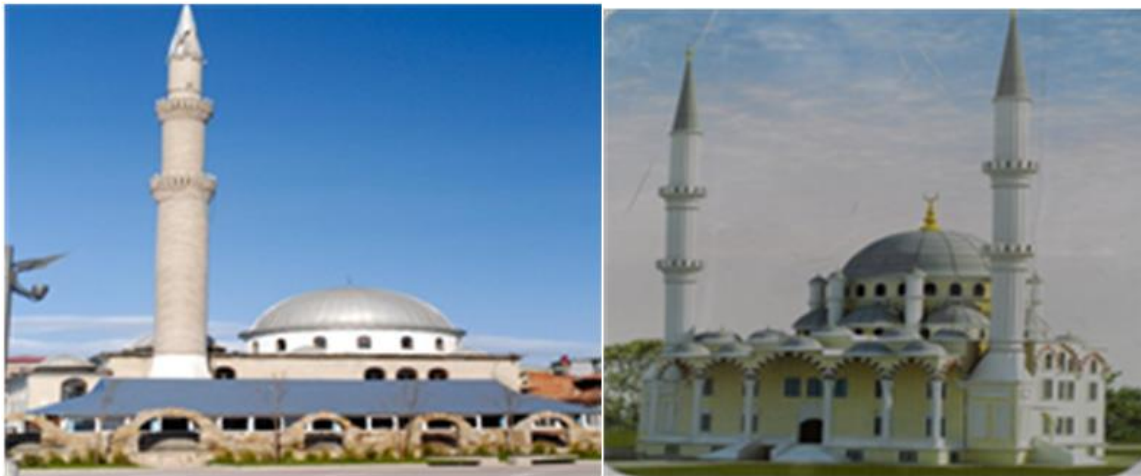
Figure 4 -5. Gazi Isa Bey Mosque - until 1999 and after 2013

During the last war of 1998 - 99, the minaret of this mosque was bombed, and only the minaret was rebuilt after the war ended. This mosque also served as a mejtep, for teaching the Quran. This mosque stood like this until 2013, when a donation was offered for its reconstruction by the Turkish state, which demolished it and built a new mosque in the same place, but with its old name Gazi Isa Bey. The old mosque had only one minaret, while the construction of the new mosque now has two minarets, the hall, the central prayer hall which is covered with a dome, the premises in front of the hall from where you enter the two minarets and the central hall.

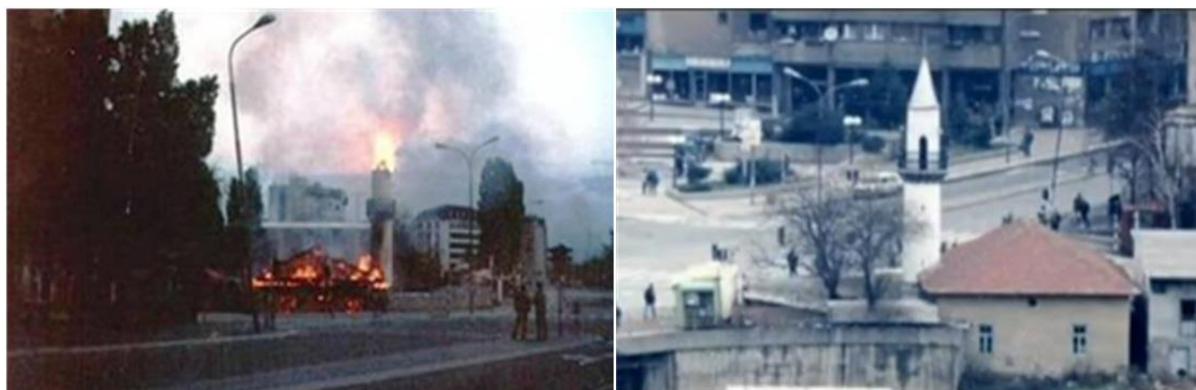
Figure 6 – 7. The Ibri Mosque before 1999 and during its burning by Serbs during the 1999 war

The Ibar Mosque was one of the oldest mosques in the city of Mitrovica, built in the distant year 1777, and served until May 2, 1999, when it was burned and destroyed by the Serbs next to the main bridge over the Ibar River. The building was burned and then the site was leveled with an excavator, where there are suspicions of a mass grave. The Ibar Mosque was one of the oldest buildings in the city center in the northern part of Mitrovica, on the banks of the Ibar River. In many photographs that are still preserved today from that part, the focus is always on the Ibar Mosque and the bridge over the Ibar River. The mosque was functional and religious services were held in it until the day of the fire. The mosque was built of stone and wood, with two windows on each of the four sides. From the main road leading to the Bosniak Quarter, the mosque was on the right and one had to descend 3-4 steps to enter the mosque's courtyard. In

its composition, the mosque consisted of a prayer hall, a portico and a minaret. The prayer hall occupied the main place and was part of a group of mosques with a wooden roof covered with tiles. According to witnesses, when the mosque was burned, the bodies of the murdered Albanians were also put there, and then set on fire. For this reason, the Serbs lost all trace of this monument of Islamic cult. In order to prove this, research should be carried out by forensic experts and justice structures on war crimes. In the city of Mitrovica, we also have several other mosques, but from more recent periods. Among them are: Hajji Veseli Mosque, which is located in the city, Bajri Mosque, a neighborhood of the city, Shipol Mosque, Ilirida Mosque, Zhabar Mosque, on the outskirts of Koshtova e Bobi Mosque, Vinarci Mosque, Kciqi i Madh Mosque, the Mosque in the First Tunnel, etc.²²

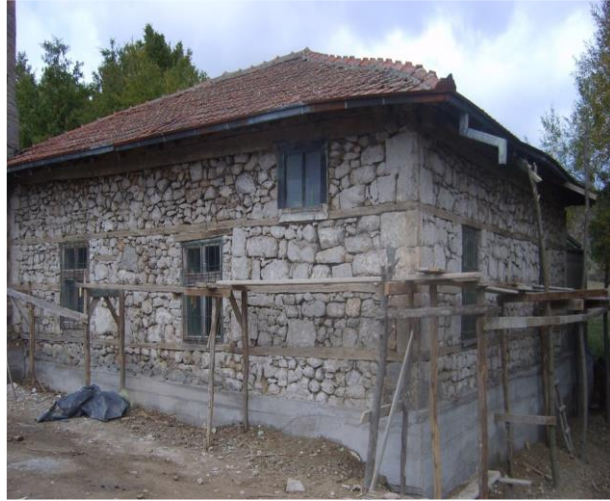
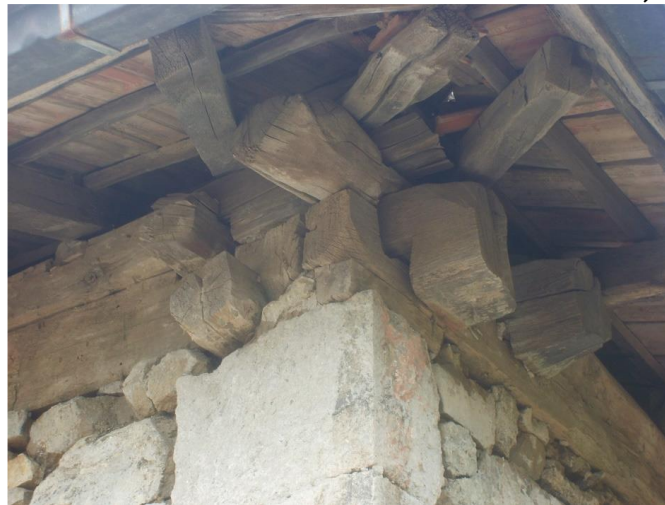
Figure 8 – 9 . The Vllahia Mosque during renovation

The village of Vllahi is located 7 - 8 km away from Trepça, which already had a mosque and a very widespread Muslim community. The inhabitants of the village of Vllahi, in addition to farming, were also engaged in the exploitation of ore from the Trepça mine. The influence of the Muslim community and contact with this community resulted in the Islamization of the inhabitants of this village among the first villages of Shala e Bajgora. After the Islamization of the inhabitants of the village of Vllahi, the need arose to build a mosque to perform religious services. The configuration of the village is divided into three small geographical units: the upper part in the north, the center of the village and the lower part in the south. The construction of the mosque in the village was decided to be in the center, although there were rumors that it would be built either in the upper or lower part of the village. The village center was also connected by the main roads that passed through the villages, and the distance from the other two parts was shortened. Although traces of construction date back to the ancient period, the oldest monument in the village is the village mosque built in 1792, 222 years ago, corresponding today to 2014. The initiative for the construction of the mosque came from the Hajzeri neighborhood, which also donated its land for its construction. The dimensions of the mosque are 13.19 x 10.30 m, it consists of a large prayer hall and an internal hallway, which is divided into two by stairs that descend from the hallway to the central hall. The hallway is raised from the base of the hall by about 0.50 m, and is completely surrounded by hand-made wood. The construction of the mosque was carried out by Dibrani craftsmen, who at that time were building towers in the village. The walls are made of stones and mortar, as well as wooden beams that reinforced the walls. The wall thickness is 0.70 m, the height from floor to ceiling is 2.85 m. It belongs to mosques with a wooden ceiling and a tiled roof. The interior arrangement consists of the Mihrab, the mimber and the hydbe, which is located on the right side of the mosque. In the middle of the mosque there is a wooden pillar measuring 20 x 22 cm, on which the beam weighs, which supports the entire weight of the ceiling and roof.

In addition to the entrance door, the mosque has two windows on each of the four sides, a total of eight windows, plus a smaller window at the level of the hydbe in the right corner of the mosque. In the hallway inside the mosque, the door of the minaret is located, which was built in 1962, from well-carved stones with the same levels. The minaret has a round shape and is somewhat wider at the base, while, as it rises, it narrows from the outside. Adjacent to the mosque was a mejtepi, where they taught Arabic reading and writing, in order to read the Quran. In this mejtepi, in addition to the children of the village, children from the surrounding villages, such as: Zhazhë, Zijaçë, Boletin, Bistrica, Maxherë, etc., attended the lessons. The imams who served in this mosque were: mullah Hasani of Gumnishte, a village in Shala e Bajgora, then mullah Ahmeti of Kaqiki in Rashan, then Halim Efendija, imam from the Hajzeri neighborhood, mullah Hasani of the same neighborhood, Hafuz Ismaili, his son, mullah Iliazi from the city of Mitrovica, mullah Hamiti of Shupkovci, mullah Shabani of Bistrica, mullah Smajli, mullah Rifati, mullah Shefqeti of Rezallë.

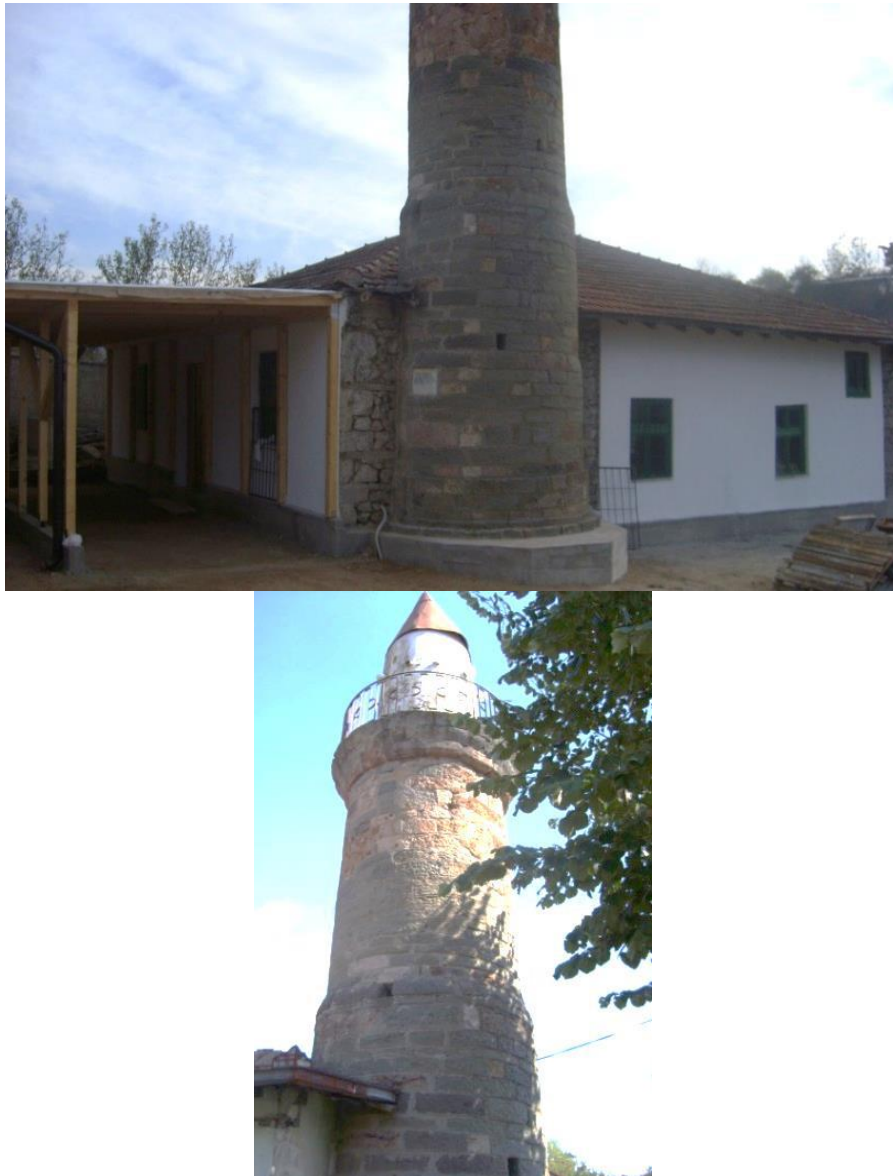
Figure 10 – 11. The minaret and the appearance of the mosque after renovation

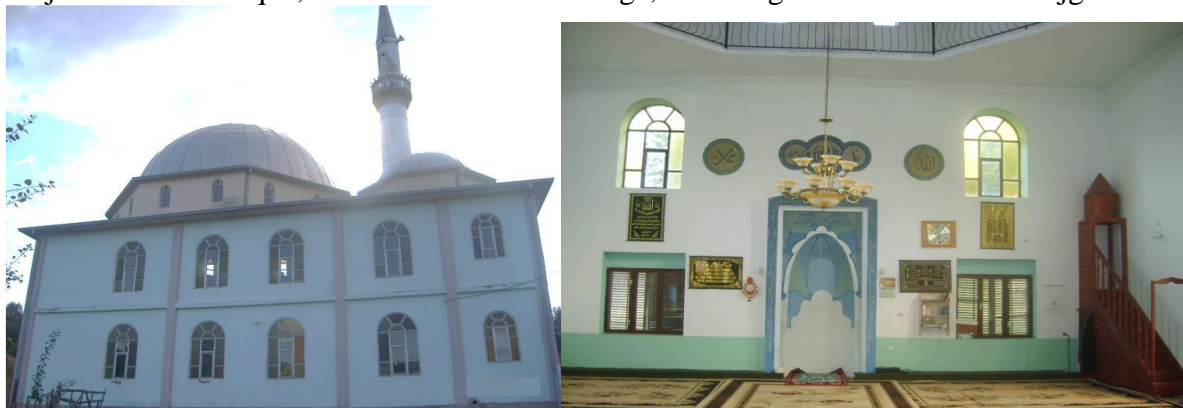
Figure 12 – 13. The Mosque of Bara and its interior

and a courtyard. The mosque is built of brick and lime construction materials, the wall thickness is 30 cm. It belongs to the domed mosques, which, in addition to the dome over the central hall, has three smaller domes over the mosque's courtyard. The mosque also has a minaret, while inside it has a mihrab and a hydba, but no mimber. The mosque is located not far from the mesjid - the old mosque, in the middle of the village, on the right side of the Bare-Bajgorë Road.

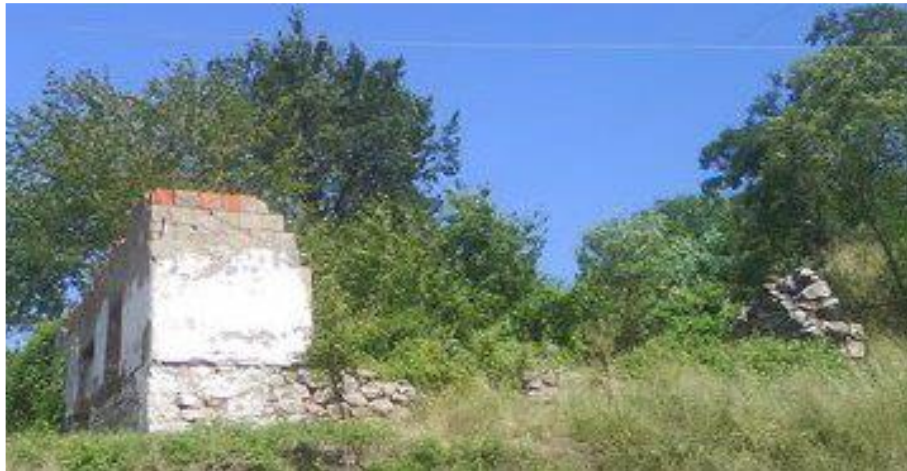
Figure 14. The mosque in the village of Dedi burned and demolished by Serbs during the 1998/99 war

In the village of Dedi there was also a Mesjid (known by the people as a mosque), which was built in 1884. The Mesjid of Dedi did not have a minaret, the construction material was stone, the binding material was mortar, and wood. In a later period, there were interventions with other materials such as bricks.

It belonged to the type of mosques (mesjids) with a tiled ceiling and roof, so it did not have a dome. During the war of 1998-99, out of the 30 houses that the village had, none had survived the fire, except for two men's rooms. Neither the village school nor the mesjid had been spared from the fire. After the war, the villagers were forced to abandon the village, as a result of the destruction that had occurred there, and as a result, the mosque was left in ruins from the war and very quickly in ruins since no one intervened to restore it and return it to a functional state.

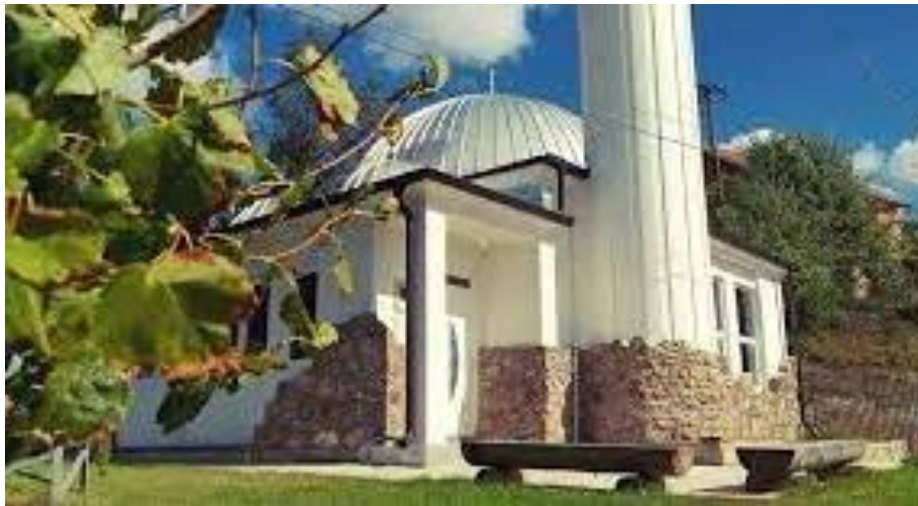
Figure 15. Dedi Mosque after reconstruction
